MONITOR

THE INFORMATION SOURCE FOR THE STRUCTURAL INSULATED PANELS INDUSTRY

ROTTING SIP ROOFS IN JUNEAU

Part I: The Base Line Info

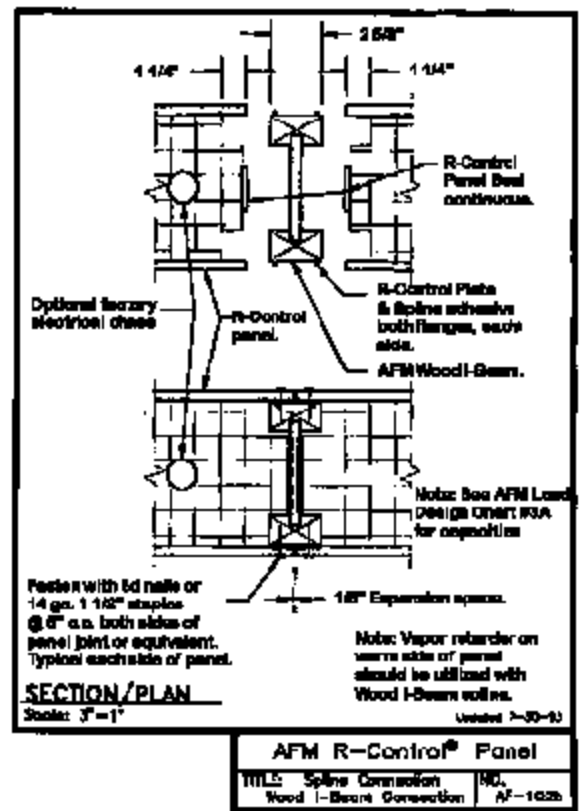
For the record, on this writer's own home, this writer observed slightly mismatched tolerances between roof panels—pre-cut by the manufacturer—and the I-beams supplied by the manufacturer. Where the top OSB panel facings were held the specified 1/8" apart, the total of the two gaps to either side of the I-beam spline is 3/8" or more. Most of that gap tends to be present opposite the side where the I-beam was installed on the ground prior to being craned into place. See illustration (right)
