PREVENTING PARTITION SEPARATION

Truss Technology IN BUILDING

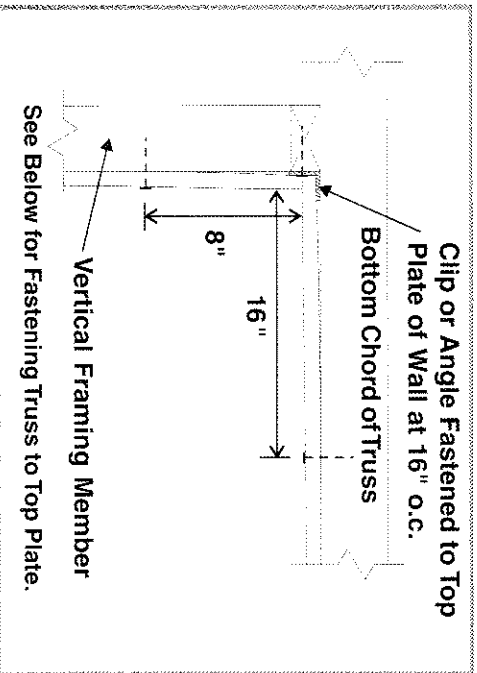
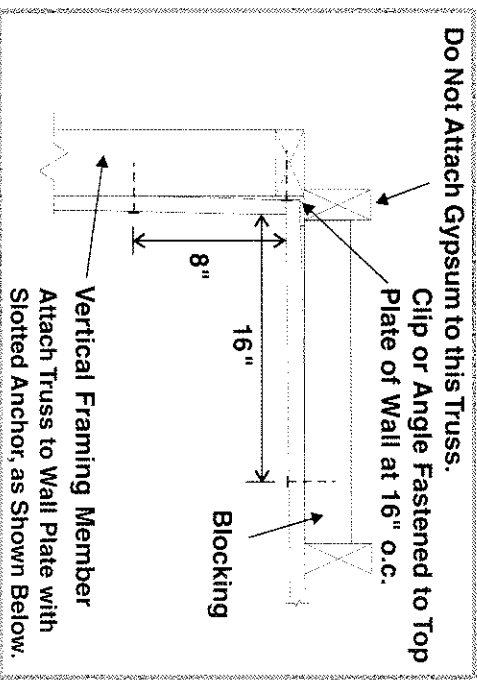
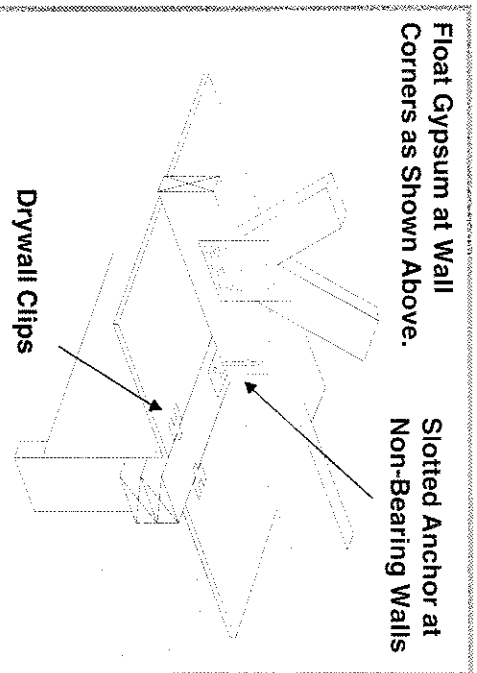
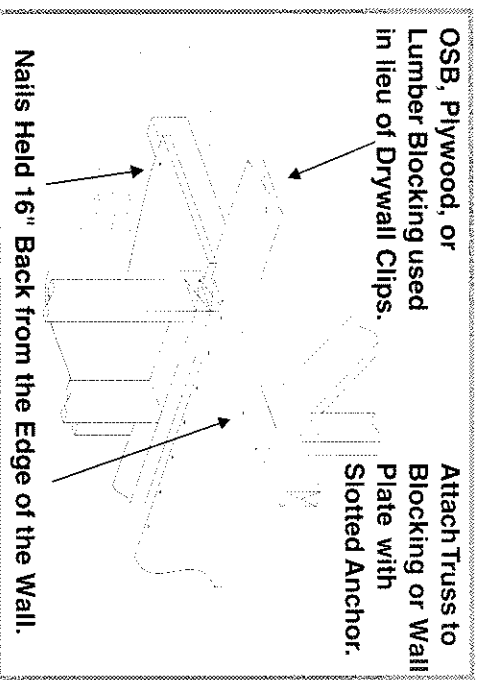
Truss manufacturers are unable to avoid partition separation by manipulating production technique, web configuration, lumber grade, species or any other variable within their control. Partition separation is also known to occur in structures where the roof is conventionally framed (stick framed). Due to these findings, truss manufacturers can assume no responsibility or liability for the subsequent damages, in the rare instances where partition separation occurs.

If this is a fire endurance assembly, see assembly details for the proper gypsum board nail or screw spacing.

WARNING: DO NOT CUT, DRILL OR DAMAGE THE TRUSS LUMBER OR PLATES.
