MONITOR

THE INFORMATION SOURCE FOR THE STRUCTURAL INSULATED PANELS INDUSTRY

ROTTING SIP ROOFS IN JUNEAU

Part I: The Base Line Info

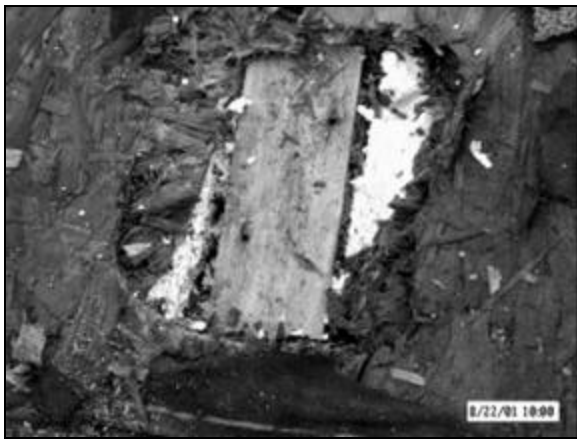
mon wall with the neighboring unit in his triplex. Yet based on an inspection two months ago, he recently settled with his insurance company. His SIP roof is due for replacement soon—a process projected to take 12 to 14 days. He'll be living in a hotel during that stretch; the per-diem cost of that stay is included in his \$85,000 settlement.

Snippen's experience with Heumann wasn't smooth. A string of flooding problems with his garden-level basement meant that his carpet had to be replaced four times within the first twelve months of occupancy. A drywall screw pierced a copper pipe, causing additional
